inglewood

ninth avenue SE

design guidelines

March 2002

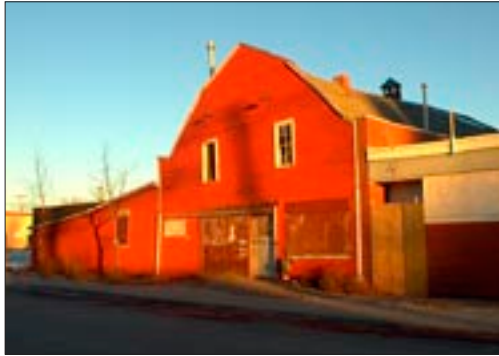
The last remaining example of a livery barn adjacent to a hotel, the former East End Livery reflects the community's early days. Built in 1908, it became a feed store and, from 1930–1998, was the home of weekly livestock auctions. It is an ordinary country barn with an urban touch—a modified Boomtown front.

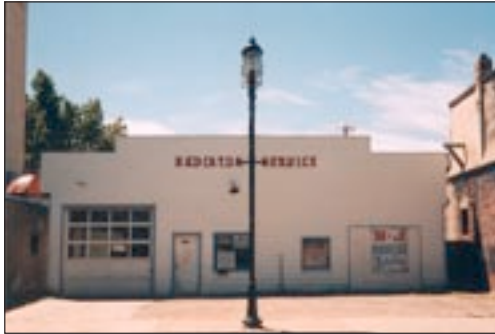
This former radiator shop is now an upscale furniture store. Built between the wars, the facade disguises the arch-roofed building behind. It is a direct descendent of the Boomtown style and an example of the many automobile-related structures once common in Inglewood.

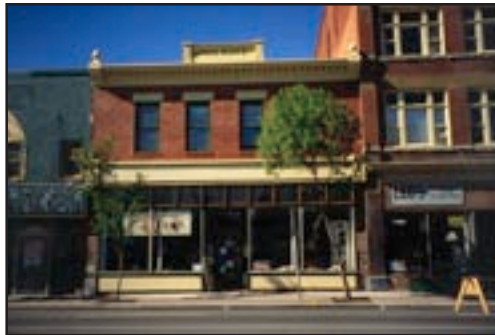
Narrow upper-floor windows and a relatively simple bulkhead panel design relate the Aull Block to the Early Commercial style, even though buildings typical of the style were less elaborate, wood-clad buildings.

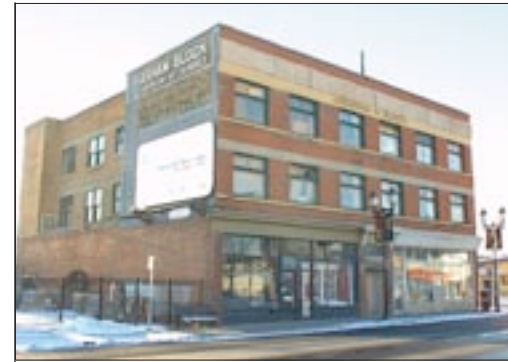
The Gresham Block's large scale, extensive glazed storefronts and broad upper window openings are made possible by structural steel supports and are characteristic of Late Commercial buildings.

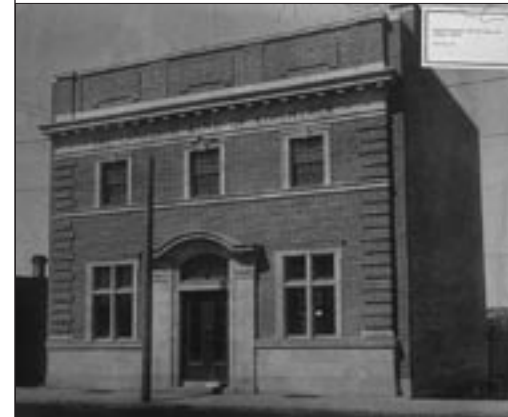
The Bank of Commerce (now CIBC) building is a Classical Revival design adapted for a mid-block location with its cornice, heavy stone-clad base, quoins, and the ornamented windows and entrance. (CIBC Archives photo)

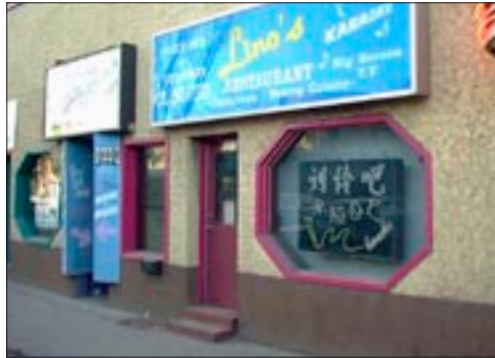
Bold octagonal windows and stucco exteriors were common and economical adaptations of the Moderne style to commercial buildings.

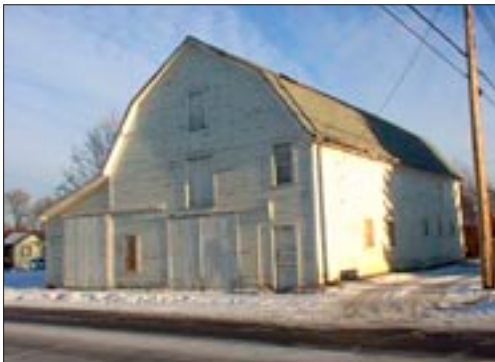
Located just off Ninth Avenue, the Stewart Barn is clad in painted wood siding similar to the exteriors of many early buildings Inglewood.

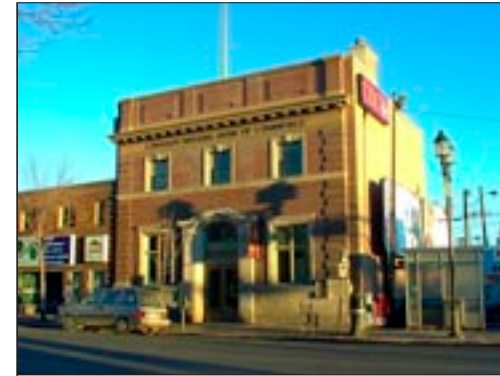
The CIBC building combines an all-brick exterior with details in pressed metal (cornice), brick (quoins and piers) and sumptuous, decorative Tyndall stone window and entryway surrounds.

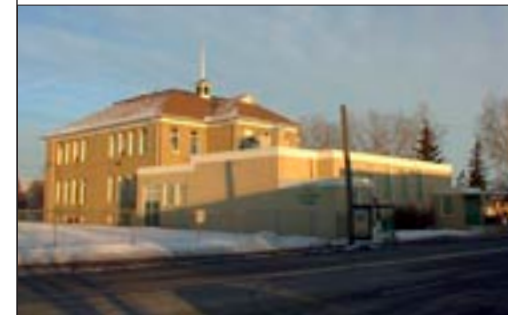
The Alexandra Centre represents several, radically different, phases of masonry construction. The original school at the rear of the complex, distinguished by its quarry-faced sandstone exterior, is obscured by much later, post-World War II concrete block addition nearest the street.

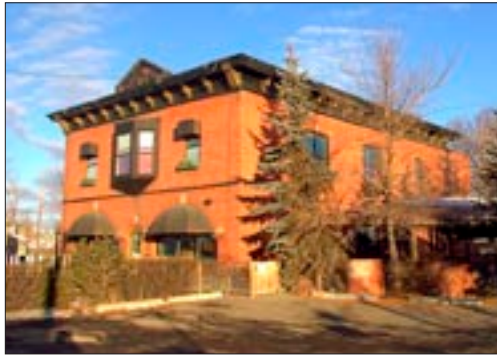
The elaborate cornice of Fire Station No. 3 is an excellent example of the prefabricated and customized pressed metal facade elements popular in the early 1900s.

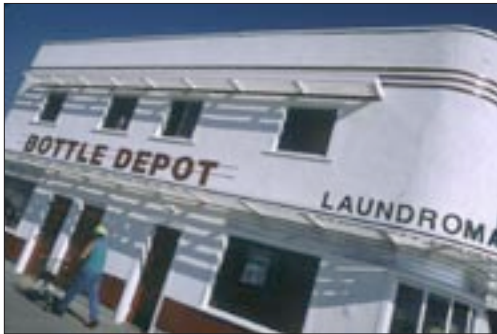
A smoothly curving stucco exterior, speed lines (upper right) and “*brise soleil*” canopies above the windows make a dramatic Moderne building.

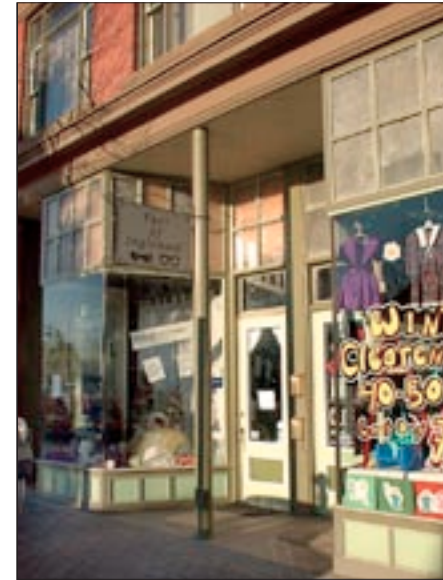
Large display windows, a clerestory of textured glass and large upper-floor windows on the Dougall Block contribute to a facade which substantially consists of glazed surfaces for a traditional brick structure. Other Ninth Avenue storefronts include glass bulkhead panels, an unusual feature intended to admit light into the basement storage areas.

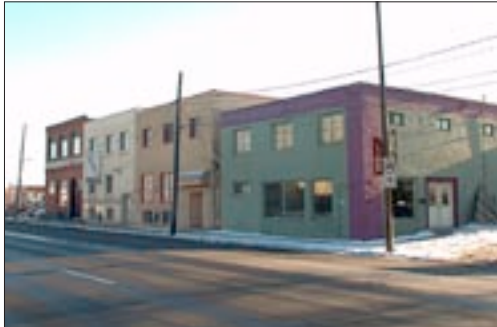
Despite significant alterations, their lack of detailing and stylistic diversity, these buildings are clearly related in overall height, width as well as in the loose alignment and rhythm of prominent facade features such as windows and doorways.

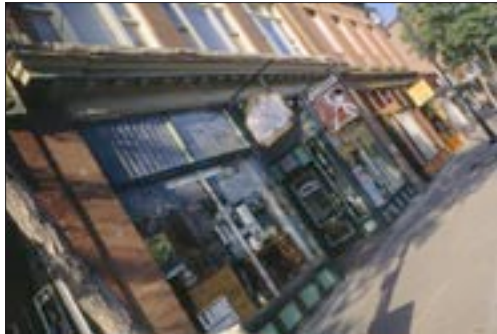
Repetition of details such as the leaded clerestory windows, bulkhead panels, recessed entrances, and brick piers maintains relationship and balance between these traditional storefronts.

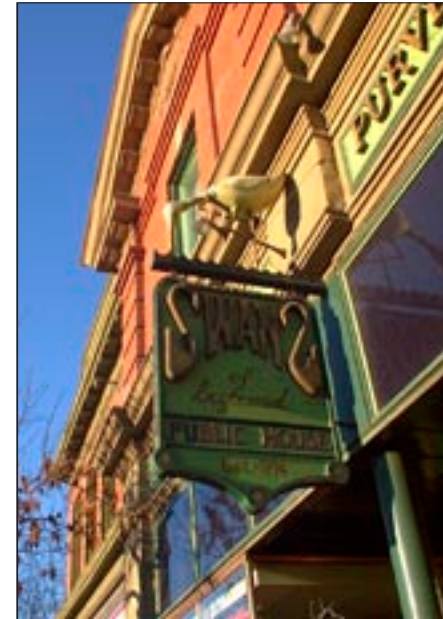
An elaborately detailed projecting sign and an accompanying fascia sign in the form of signband lettering (upper right). Layers of mural-sized wall signs are still legible (below) and were common in commercial areas. Restoration of these “ghost signs” has become popular.

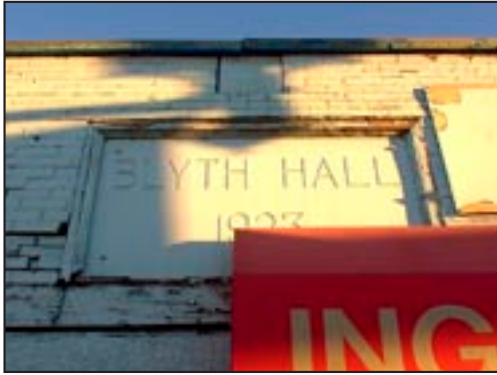
An inconspicuous but interesting architectural sign identifies Blyth Hall and its date of construction, 1923.

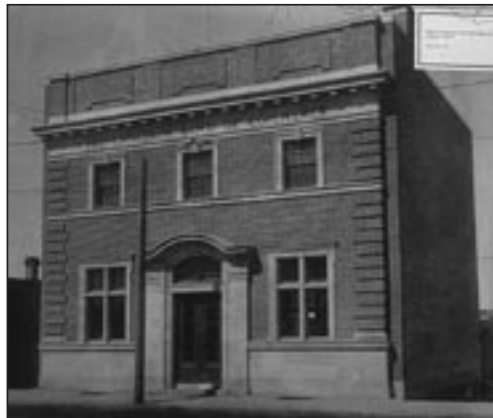
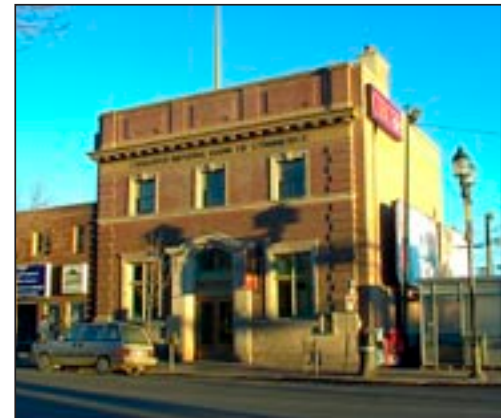
This archival photograph of Inglewood's Bank of Commerce building provided evidence for a flagpole, which was reintroduced in as part of the facade restoration program (right). (Photo below courtesy of CIBC Archives)

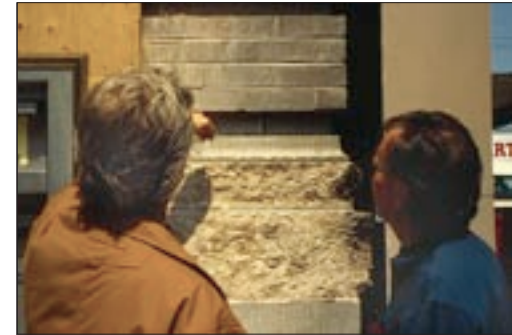
Architects inspect original brick and Tyndall stone details beneath a “slip cover” on the CIBC building as part of preliminary planning for the building rehabilitation project. The stone details had been hacked away by renovators and were costly to replace.

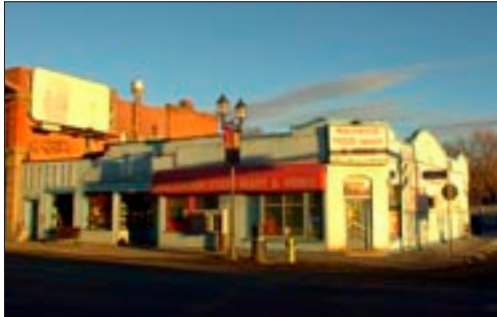
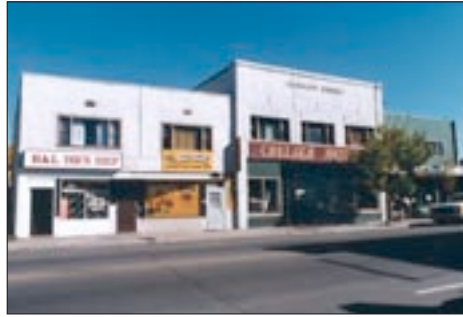
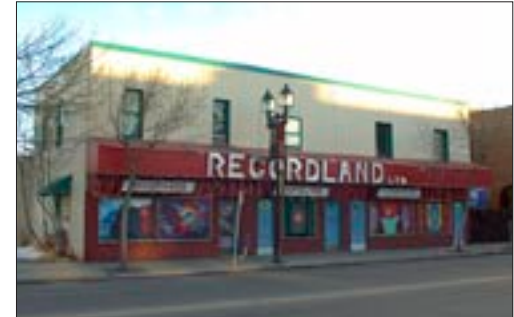
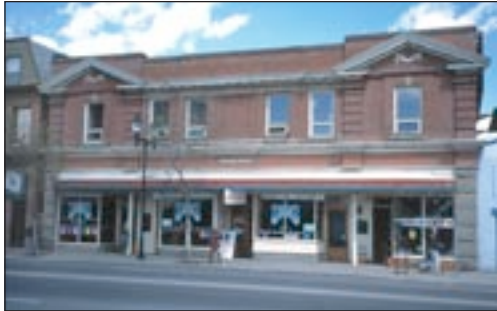
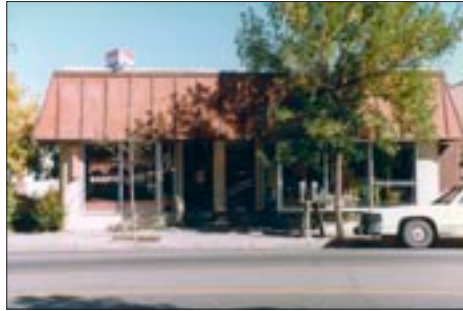
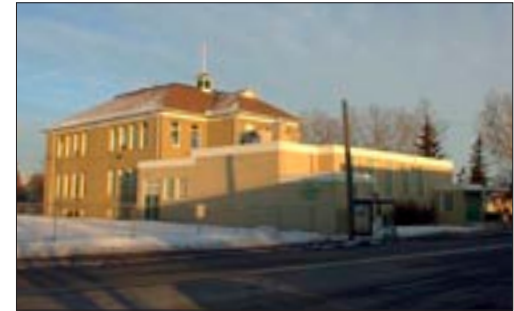
Minimal Alteration Blyth Hall (top) and the Carson Block (lower example) have experienced only superficial exterior alteration over the years. Each building's historic character is apparent and can be restored through minimal intervention such as the removal of paint and inappropriate awnings and signage.

Moderate Alteration The Befus Block (top) and Faces building (below) facades are more extensively altered, but they retain enough original design elements to determine their historic character. The Befus Block's brick facade was restored from beneath the stucco, and the upper windows and cornice were reinstated. Among other changes, a wood mansard roof was removed from the Faces building to reveal a curved Moderne facade and entranceway.

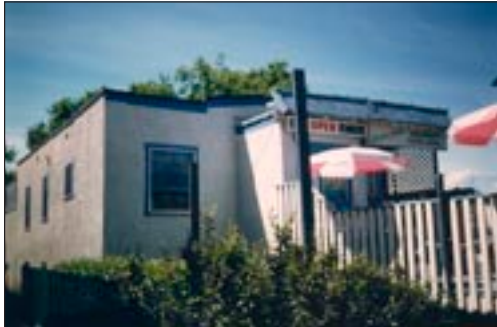
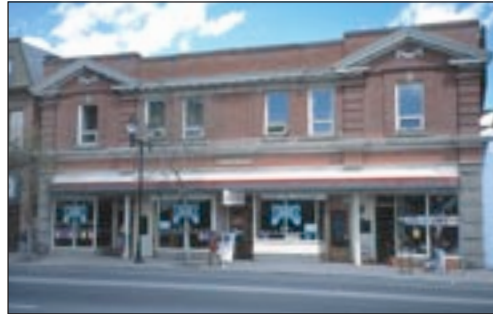
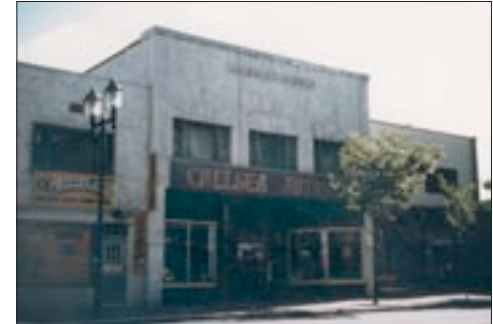
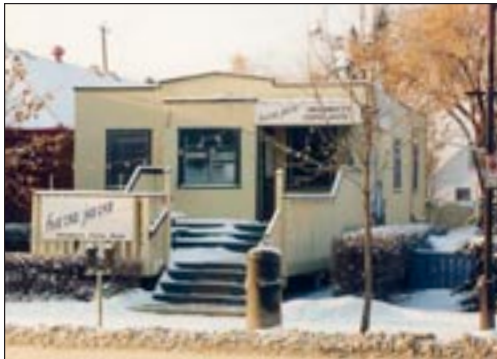
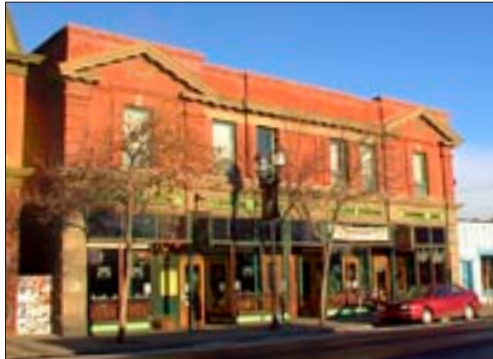
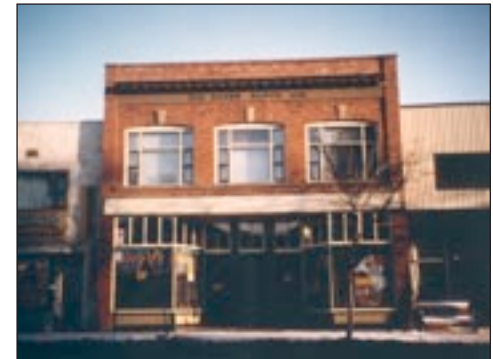
Enhancement Transforming one of Ninth Avenue's few remaining houses into a bistro and coffee shop required relatively little design intervention. Enhancements included the removal of redundant signage and unnecessary wires, windows repairs, and repainting of the building and deck.

Restoration and Repair Most rehabilitation work on the Carson Block occurred at the lower storefront level. It included restoration of the entryways, installation of new storefront glass, replication of missing brass details around the windows, and repair of all the original door hardware. The entire brick facade was repointed where necessary and cleaned.

Reconstruction An intensive rehabilitation program was needed to restore the Befus Block. Work included stucco removal from the entire facade, and the subsequent removal, cleaning and reinstallation of the bricks. New upper floor windows were built to fit the original openings and an upper cornice was assembled and installed to replicate the missing original feature. Extensive reconstruction of the lower storefront contributed to the restoration of this building's historical character.

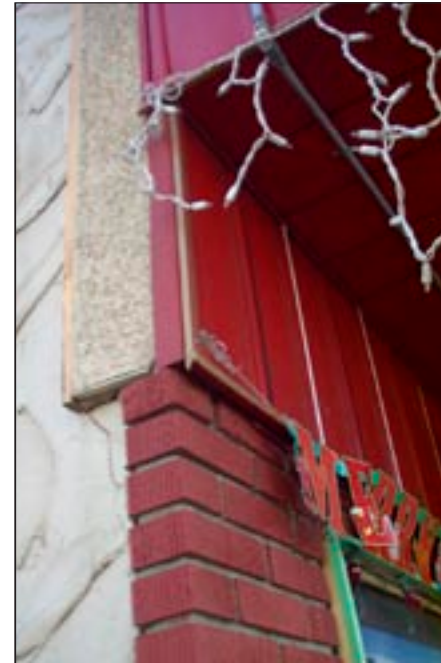
Layered finishes on this facade include a heavily textured stucco, brick veneer, and prefinished sheet metal, reflecting successive programs to update the building's appearance in low-maintenance materials.

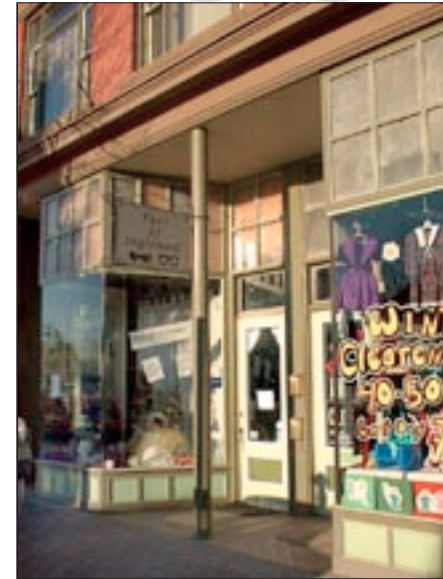
The alignment and detailing of bulkhead panels on the Dougall Block match the rhythm of the clerestory windows above, lending continuity to the outward-facing and recessed portions of the storefront and drawing the pedestrian's eye inward from the sidewalk.

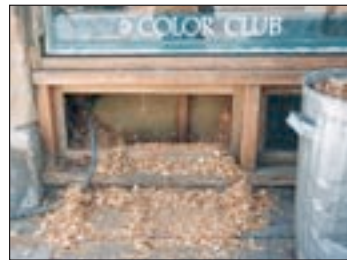
Above, investigative work on the bulkhead panels for the Fraser and Seabloom Block uncovers wood shavings used as insulation. Original details included wood profiles and unique glass bulkhead panels reinforced with embedded wire mesh. The completed storefront is shown below, right.

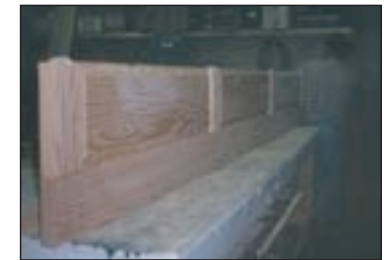
Bulkhead panels for Junktiques are assembled on the basis of research and the experience of a restoration architect. No evidence of the original design survived on the significantly altered storefront.

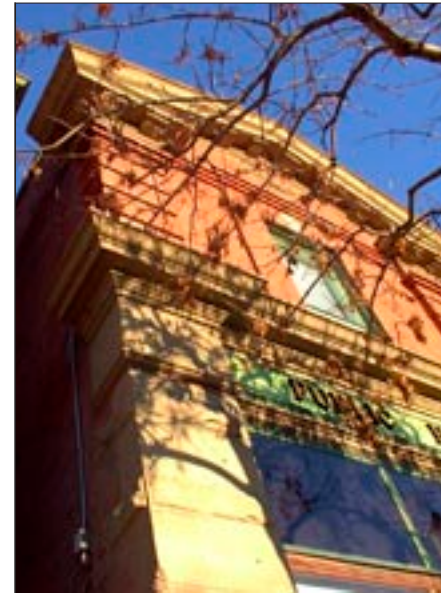
Masonry piers link the Carson Block's upper and lower facades and define bays at either end of the building (see below). But the piers' transition from sandstone to brick also serves to keep the building's upper and lower levels distinct.

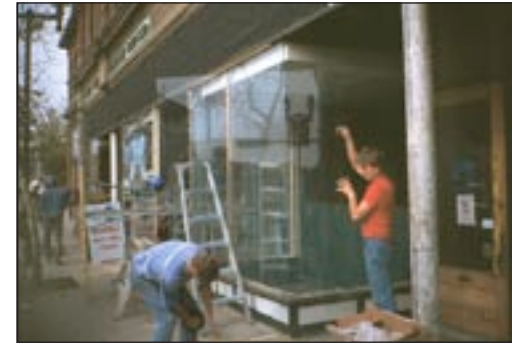
Installation of plate glass windows on the Carson Block.

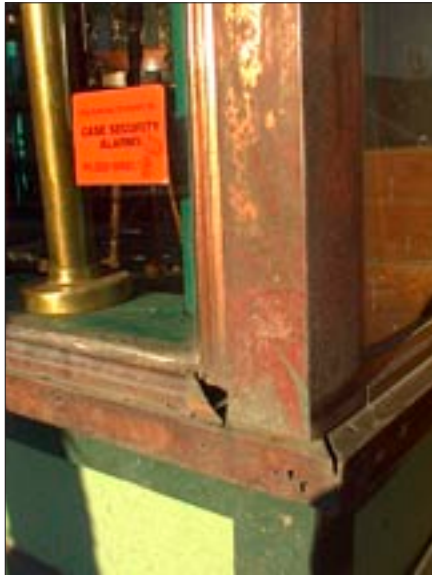
Brass window frames are a distinct feature of the Carson Block storefronts. Repairing these elements and replicating missing pieces was accomplished with the expertise of a local sheet metal shop.

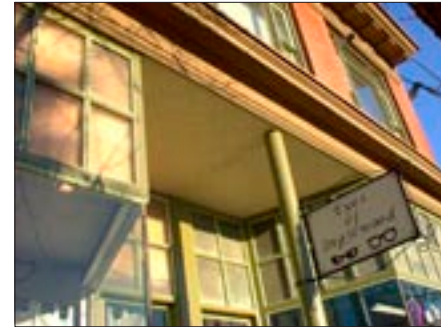
A continuous band of clerestory windows unifies the Dougall Block storefront. The textured glass lights, or individual panes of glass, appear to be fitted with a backing material that reduces interior heat buildup in the absence of a retractable awning. The patterning of the recessed entry's pressed metal ceiling complements the texture of the clerestory windows.

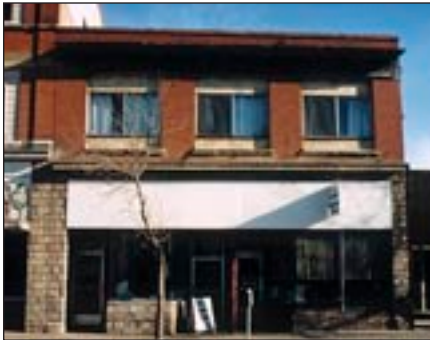
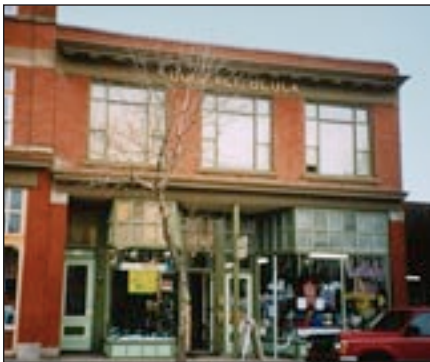
Photographs of the Dougall Block before and after facade rehabilitation illustrate the impact of exposing and reinstating the clerestory windows. The display and upper floor windows have also been restored to their original dimensions.

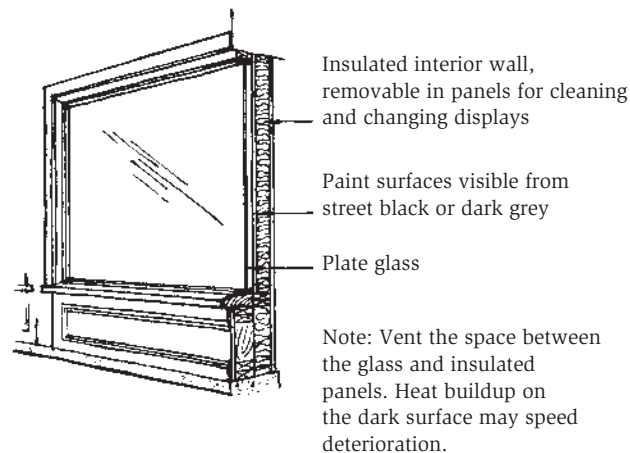
Simulated windows, as above, are a helpful compromise if interior alterations prevent the restoration of historic window openings. Use of a dark-coloured backing material is an alternative to back-painting the glass itself.

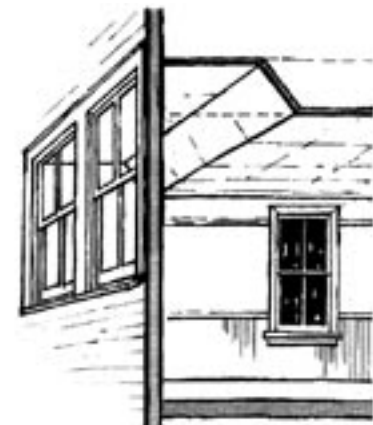
Section of a storefront showing modification of a T-bar or drop ceiling found in many shop interiors to accommodate original, full-height windows.

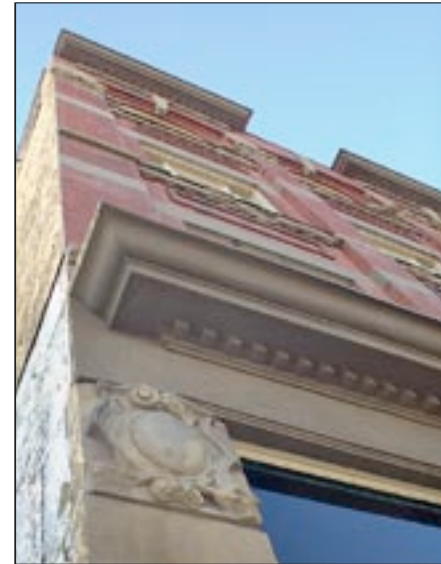
The lower cornice of the Fraser and Seabloom Block features a distinctive moulding profile, decorative “dentils,” and a sand-paint finish. The continuous lower cornice balances this building’s unusual split upper cornice.

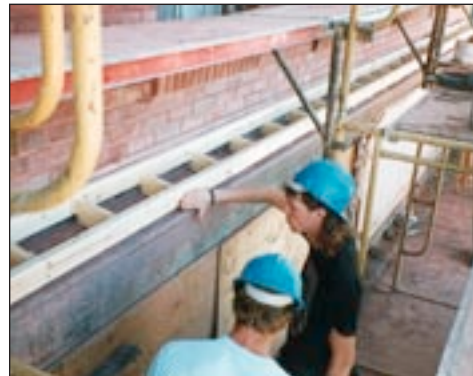
The rehabilitated lower cornice of the Burn Block, showing the textured sand-paint treatment and letters mounted into the signband. This simplified detailing of this lower cornice is appropriate in situations where there is insufficient archival information or physical evidence to attempt a reconstruction.

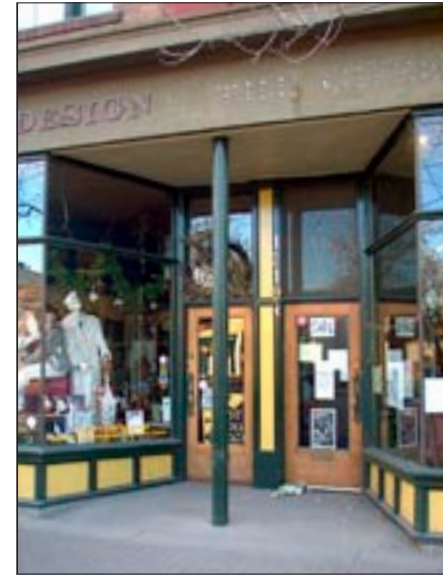
A steel column helps support the wide recessed entrance needed for these twin doorways on the Burn Block.

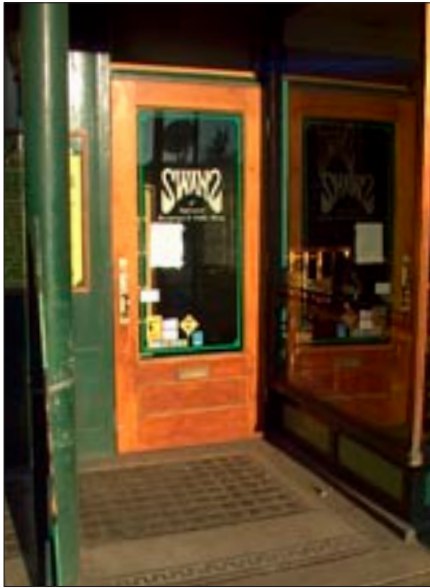
Patterned hexagonal tile flooring in the entryways to the Carson Block (above). Unique to this building is the embedded glass blocks which admitted light into the basement. The entrance doors (far right) were repaired and varnished. The original brass door hardware was also repaired and reinstalled in an effort to retain as much original historic fabric as possible. Another unique entrance, on the Aull Block (right), features a terrazzo floor with inlaid brass lettering.

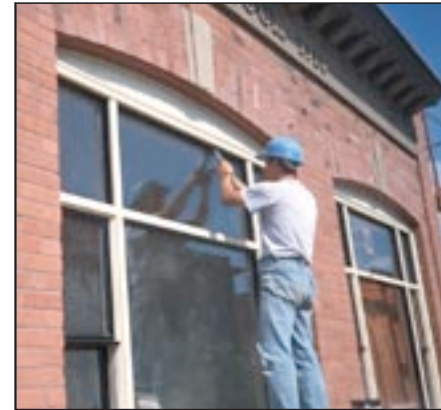
The upper windows on the Befus Block are restored to their original size and configuration with high-performance thermal pane units. The bracketed cornice detailing is visible above.

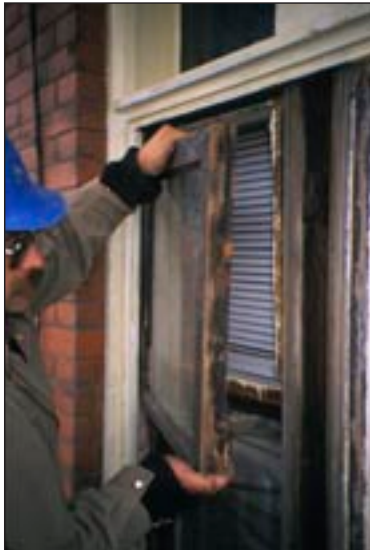
Individual storm windows are removed from the Fraser Block for restoration.

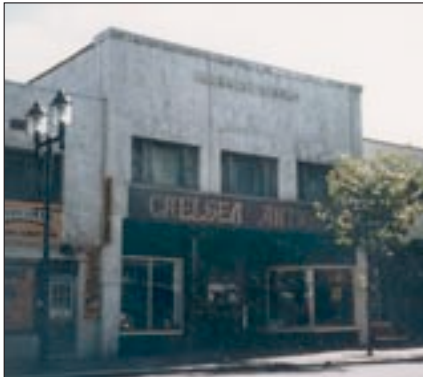
The Befus Block after rehabilitation, with new high-performance windows custom made to the original size and configuration. Keystones above each window were uncovered and repaired, while the clerestory windows below were reopened to illuminate the store interior.

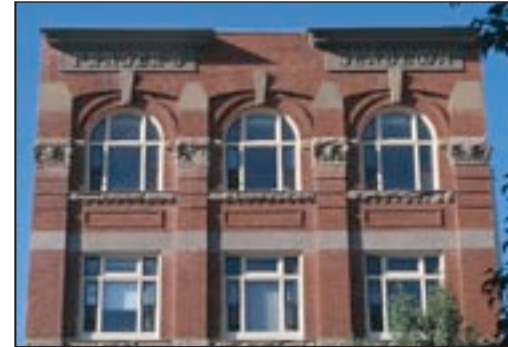
The Fraser and Seabloom Block's three bays terminate in an arched window accented by curved hood mouldings and brick arches with keystones.

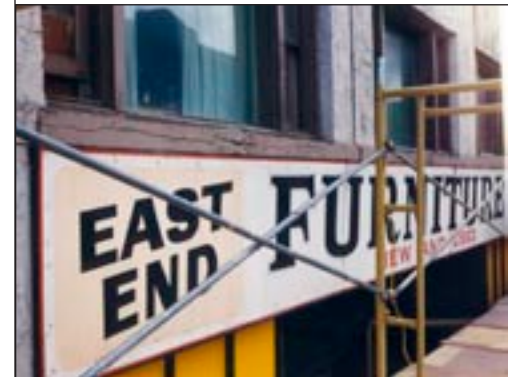
Sill deterioration of the Burn Block's upper floor windows, before rehabilitation.

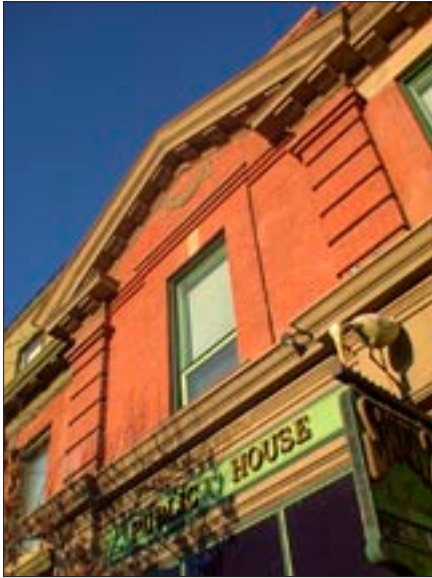
This end pavilion of the Carson Block illustrates the relationship of upper and lower cornices, in which the latter is less detailed, lower-profile and clearly subordinate to the upper cornice. Original design details such as the decorative “swags” immediately below the cornice were restored as part of the facade rehabilitation program.

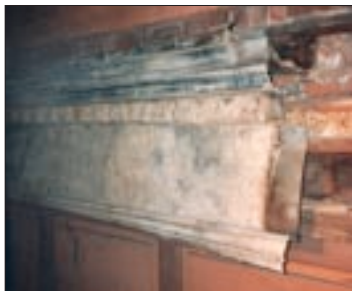
The upper facade of the Fraser Block with the cornice removed. Pressed metal cornices are generally lightweight structures supported on brackets or wood outriggers.

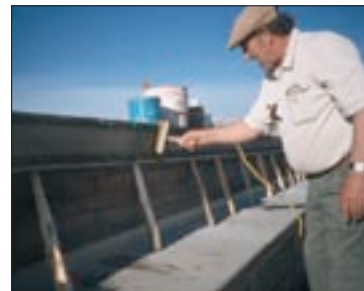
Application of sealer to the parapet of the Fraser Block.

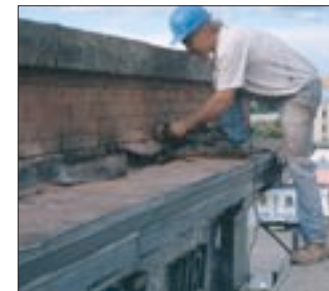
Although they are seldom visible from the street, cornice and parapet flashings are details that are crucial to the long-term preservation of building fabric. The flashing below is affixed and sealed into a groove, or reglet, in the masonry to provide a durable water barrier.

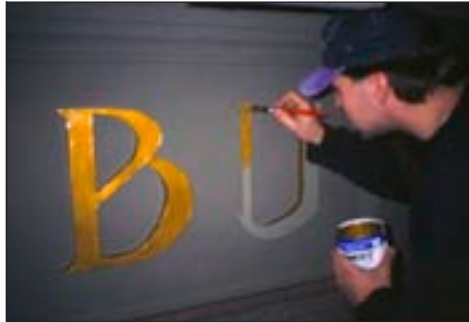
The letters of the Burn Block are repainted with “Hammerite” gold paint to resemble the original gold leaf finish from street level.

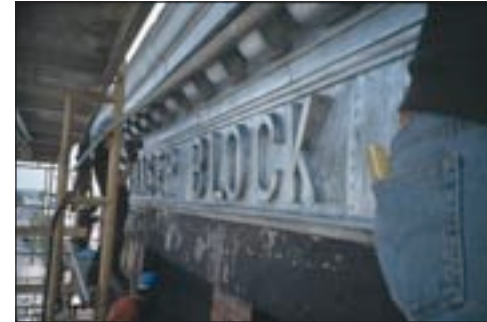
Missing architectural details rebuilt from new, more weather-resistant materials are prepared for installation on the cornice of the Befus Block.

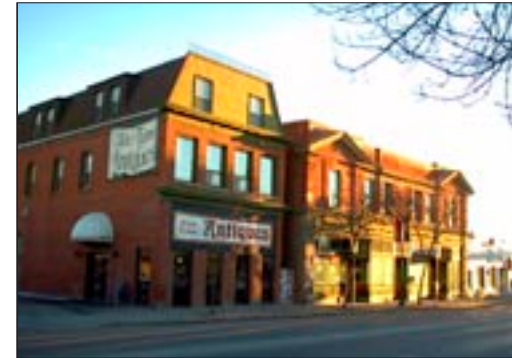
The unusual character of the Haskins (Victory) Block is owing in part to the exposed mansard roof of the building's third storey. The visible roofline of the neighbouring Carson Block is modulated by a varied treatment of the cornice which articulates the building's three main bays.

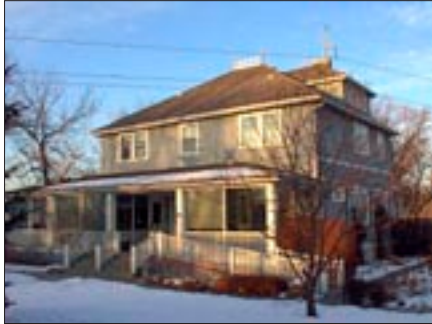
Cedar shingles and cresting on the hipped roof of the Deane House are character defining features. One of the few buildings on Ninth Avenue with a roof visible from the street, this historic residence-turned-restaurant is a gateway to historic Inglewood as one enters the community from downtown.

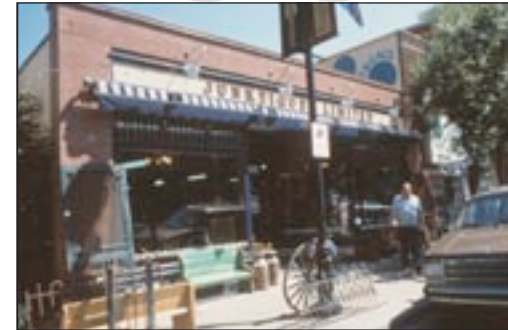
A retractable awning can adapt to a wide range of lighting conditions. The striped fabric enlivens the storefront and coordinates well with the facade and signage colour schemes. The daily ritual of extending the awning indicates that the business is open and becomes part of the rhythm of life on the Avenue.

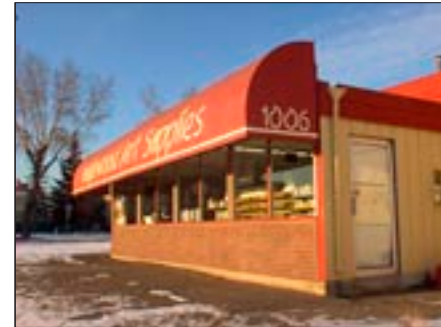
Vinyl “bubble” awnings are popular as combined sun-shades and signage. Despite this functionality, these awnings’ materials and standardized dimensions make them unsuitable for historic buildings.

On the other hand, there is no escaping the fact that these “bubble” canopies are a mass-produced product that is often difficult to adapt to buildings with any kind of heritage character. As a result they can overwhelm the existing facade. Although they may shelter an entrance from inclement weather, these fixed canopies must be carefully designed and situated to avoid creating a hazard to pedestrians, particularly in winter when melting snow drips onto the sidewalk below and freezes.

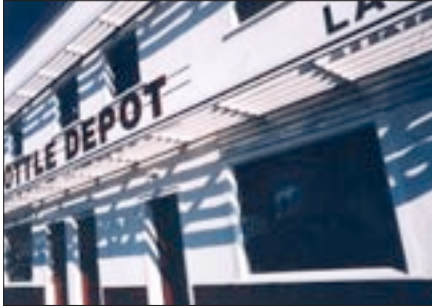
Instead of traditional retractable awnings, this moderne building incorporates louvred canopies, known as *brise-soleils*, which provide some shade and cast dramatic shadows across the stucco facade.

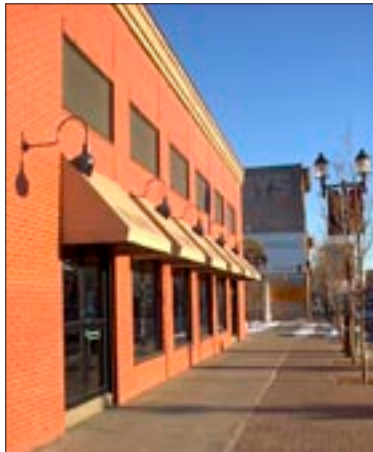
Appropriate awning shapes for historic buildings and buildings which are modeled after traditional storefronts.

- A. Keep signband exposed
- B. Use a single-slope awning design
- C. Narrow fascia or valance
- D. A decorative bottom fringe
- E. Sufficient sidewalk clearance

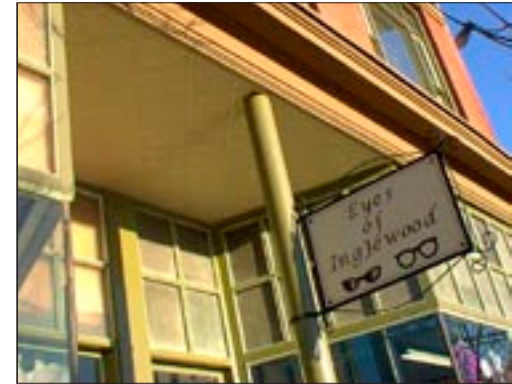
A signboard and support structure are elegantly integrated into the structure of the Dougall Block storefront. The sign is just large enough to be easily readable from the sidewalk without obstructing the storefront.

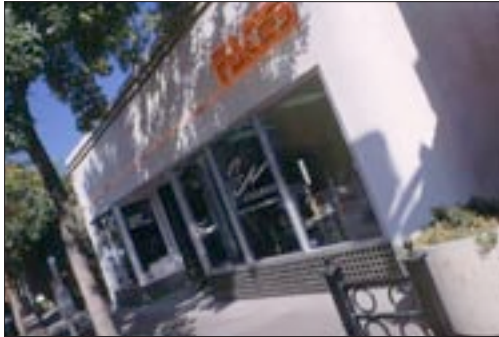
Neon lettering arranged asymmetrically on this moderne facade reinforces the building character and is effective under a wide range of lighting and weather conditions.

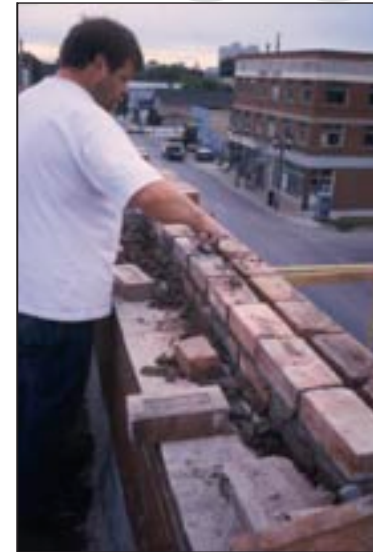
The original parapet wall on the Carson Block was dismantled, repairs were made, and the wall was reconstructed using the original bricks.

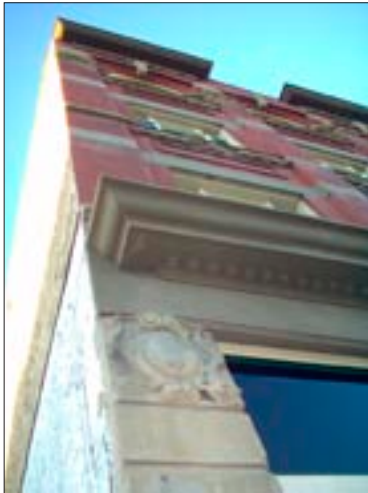
The masonry and sandstone elements of the Fraser and Seabloom Block underwent an extensive cleaning program.

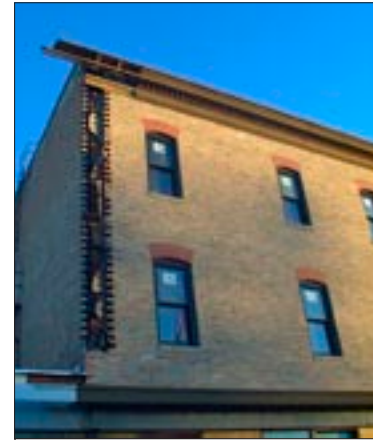
The facade restoration of the National Hotel (in progress above) included the complete dismantling of the brick veneer which had been compromised by earlier sandblasting efforts. The bricks were turned around and reassembled so that the original, more weather-resistant masonry was preserved on the building's visible exterior.

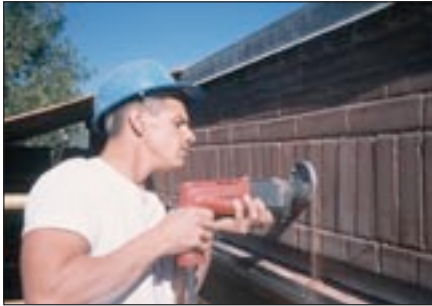
Applying consistent and gentle pressure, workers remove residual adhesive that once secured metal sheeting to the brick veneer.

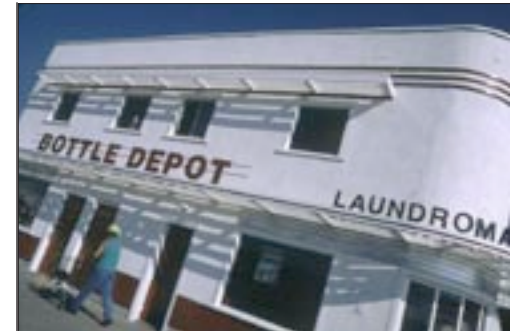
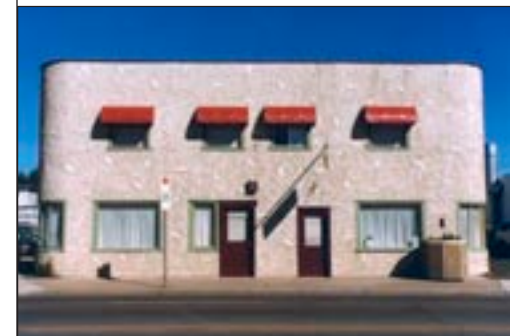
The restoration program included the removal of a heavily textured, Spanish-style stucco (below) and the application of a smooth stucco (above) to match the building's original colour and texture.

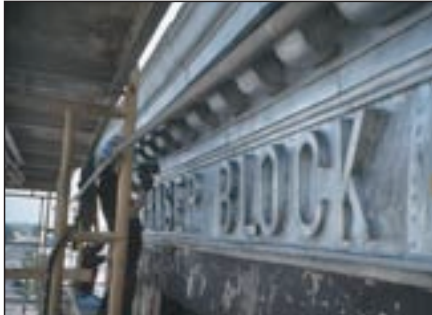
The original upper cornice of the Fraser Block was stripped of weathered paint and repaired to seal holes in the sheet metal and to prevent water from pooling on the cornice cap or ledge above. The cornice was then repainted.

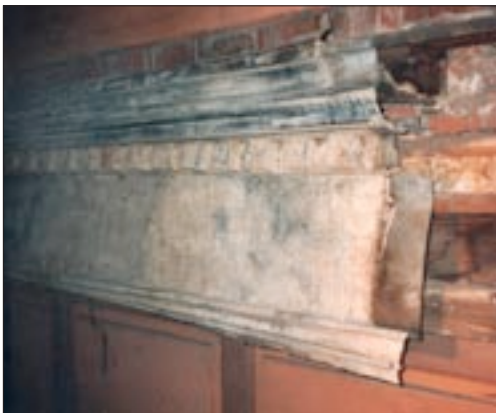
The elaborate cornice of the historic fire hall reflects the light weight and, historically, cost-effective pressed metal construction of this character-defining architectural feature.

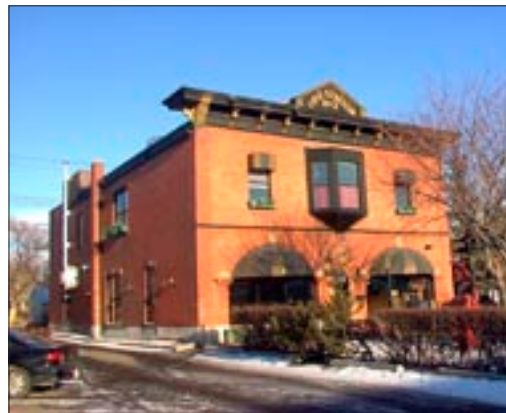
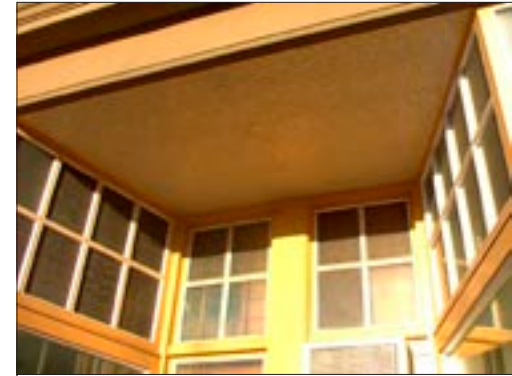
Investigative research revealed the original patterned "tin" ceiling in the Dougall Block's recessed entrance.

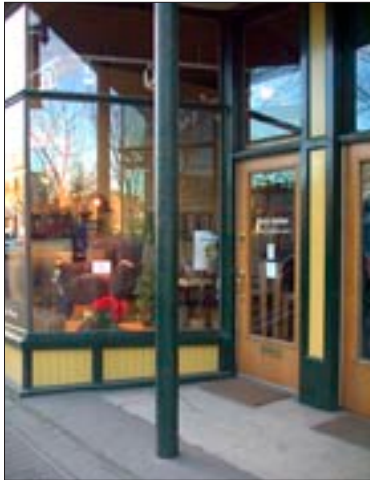
Rolled steel rather than cast iron columns are structural elements on the Avenue's traditional storefronts (above). Steel's structural importance continues in post-war designs (below), where raking steel columns support a canopy that reaches out to motorists.

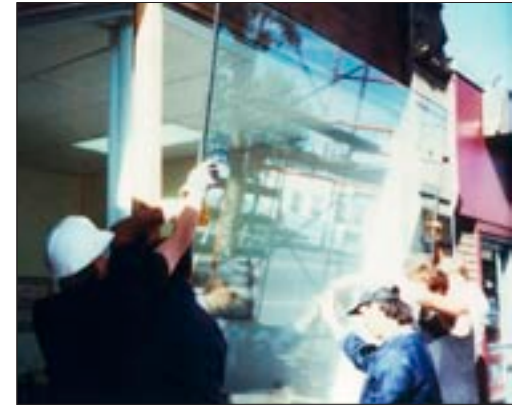
Installation of new display window glass in the Fraser and Seabloom Block.

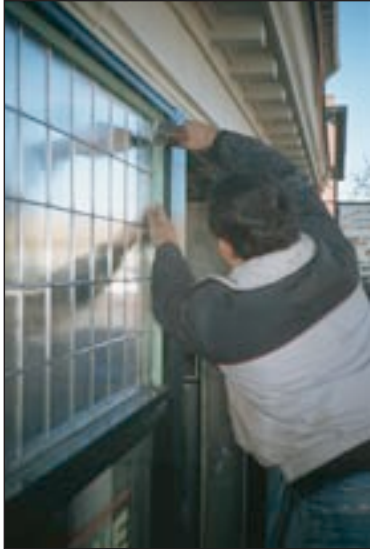
A local glass craftsman repaired the original leaded glass clerestory windows of the Fraser Block, retaining as much historic fabric as possible.

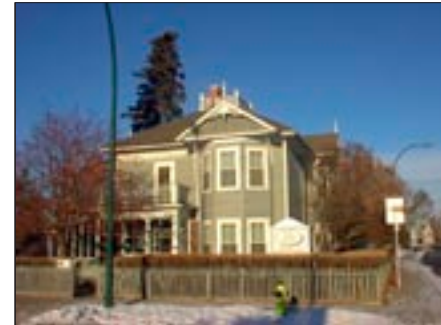
The historic Cross House represents some of Inglewood's most detailed exterior woodwork. Ornamental wood cresting and bargeboards like these were popular in Victorian times but required regular maintenance.

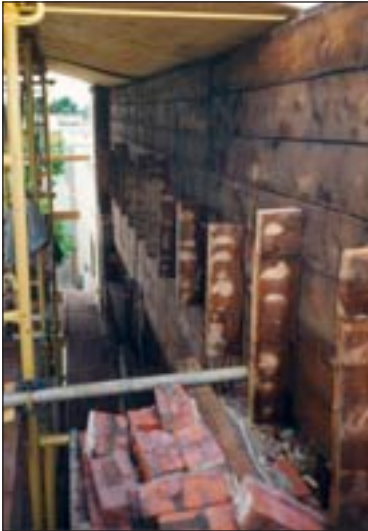
This building's brick veneer was removed to expose and repair rot occurring in the underlying wood frame construction.

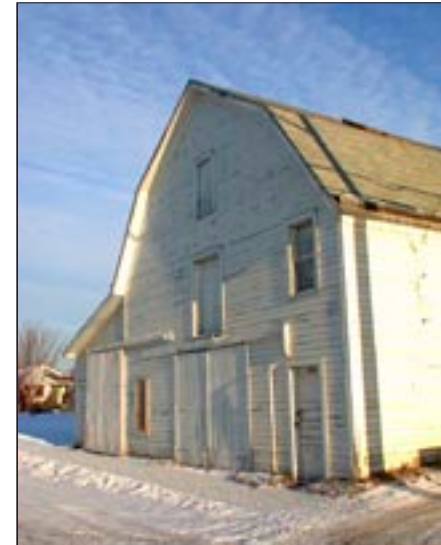
The vacant Stewart Barn built in 1909 (known locally as the "cinnamon barn") has remained in good condition over the decades as a result of an ongoing paint and maintenance program.

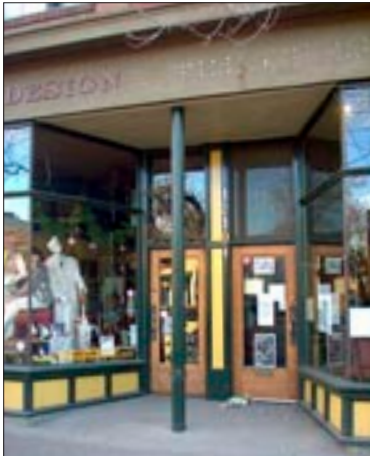
The yellow bulkhead panels and dark green trims are based on colours typical of the early 1900s. The complementary colours read clearly and highlight the construction details of the Burn Block storefronts. A sandpainted signband above the is compatible with the historic colour scheme, but neutral enough to provide a suitable backdrop for lettering and business signs.

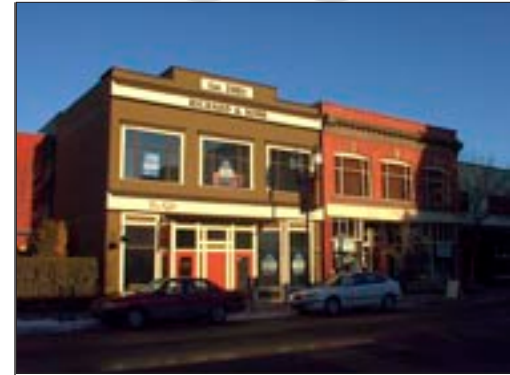
Completed in 2001, the Richard & Sons Block adopts the architectural vocabulary of the neighbouring Befus Block, built nearly a century earlier. Historically-derived design elements include a cornice and raised parapet, and a recessed storefront entrance with bulkhead panels. Wood was selected for the exterior to respect and reflect the character of the historic building previously occupying the site.

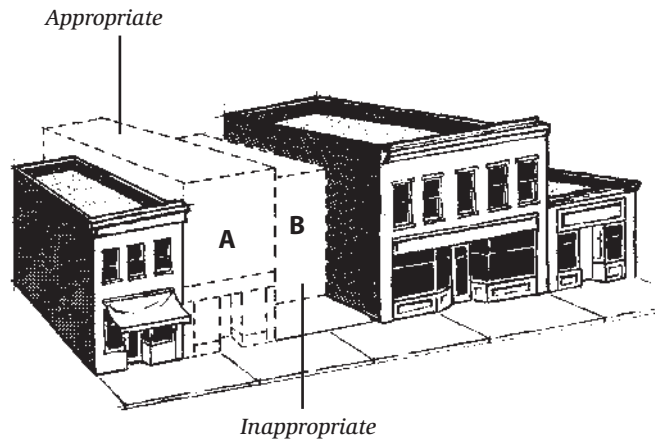
New construction should maintain the continuity of storefronts along the street. Building A reinforces the flow between storefronts while Building B interrupts the sequence of storefronts.

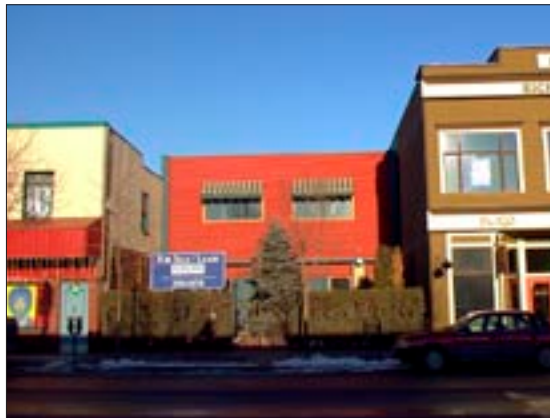
Although a set-back was required by the City of Calgary for this new development, the developer successfully incorporated design elements into the facade that visually and physically draw the building closer to the street.

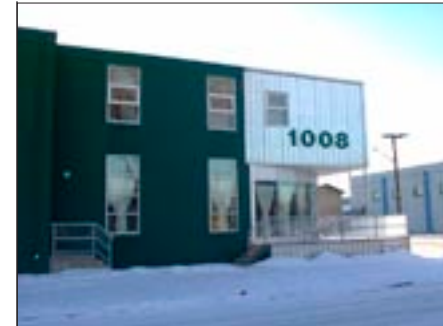
Located a block south of Ninth Avenue, this new commercial building responds to Inglewood's industrial heritage through strong, simple forms and galvanized steel cladding, even as the signage, curving windows and other elements identify the design as fresh and contemporary.

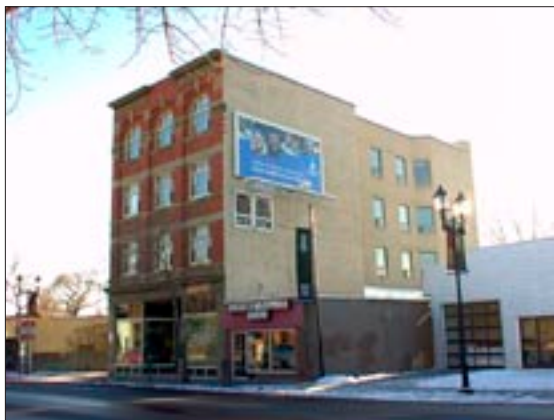
The Fraser and Seabloom Building (left) stands in splendid isolation from its neighbours, illustrating the impact of building heights and horizontal alignments (such as the belt courses defining each storey) on the streetscape. At right, Spolumbo's late-1990s facade presents an extensive street frontage but uses regularly repeated canopies and horizontal details to maintain rhythm and scale compatible with the traditional streetscape.

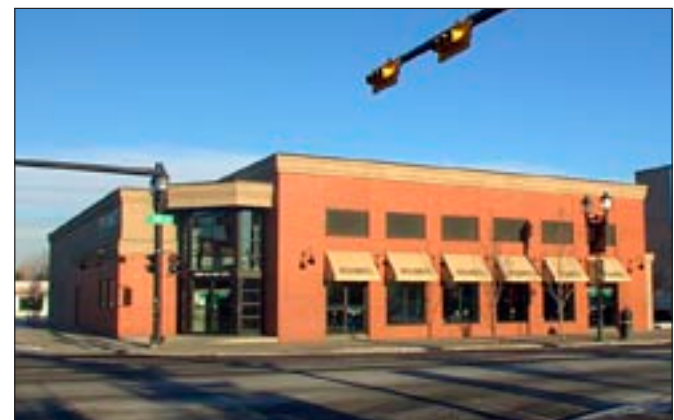
In a traditional context, this infill example maintain the pattern of building components along the street:

- A. Recessed front door
- B. Large display windows
- C. Signband located above storefront
- D. Repetitive, vertically proportioned upper windows
- E. Upper cornice or special roofline treatment
- F. Building width respects pattern set by neighbouring facades

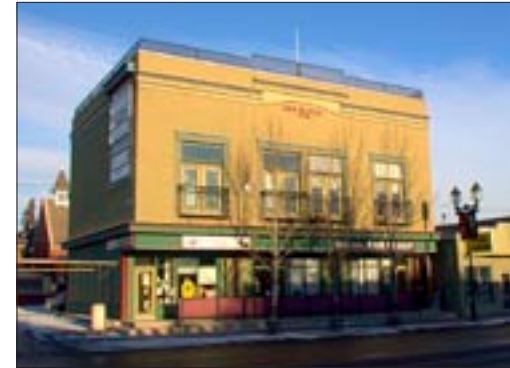
The Lea Block uses a coordinated colour scheme based on the palette of its older neighbours and incorporates traditionally-inspired elements as a rooftop flagpole. Permanent lettering identifies the building and its date of construction beneath a simplified, contemporary interpretation of a cornice.

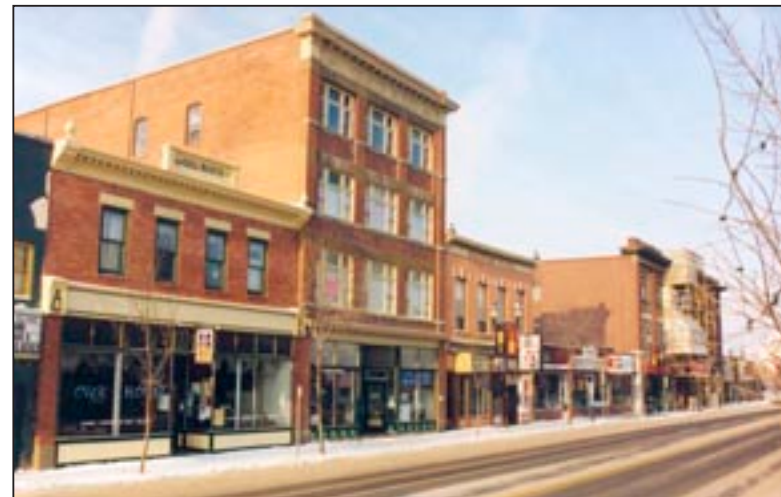
Varied building heights on Ninth Avenue reflect different construction periods and the optimism of Inglewood's early development boom. Although the Aull, Fraser, and Seabloom Blocks are dissimilar in height, each building's principal facade elements and the divisions between the upper storeys align with those of its neighbours, giving continuity and harmony to the streetscape.

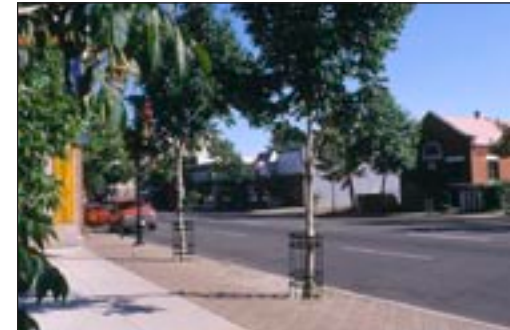
Parking areas can be screened by a fence or similar barrier. Trees and other plantings along the edge of parking areas or vacant lots can also help to maintain the street edge and serve to soften the abundance of "hard" surfaces. Just some of the additional benefits of vegetation include lowering of summer temperatures and dust control.
